# Concrete degradation

**Concrete degradation** may have various causes.

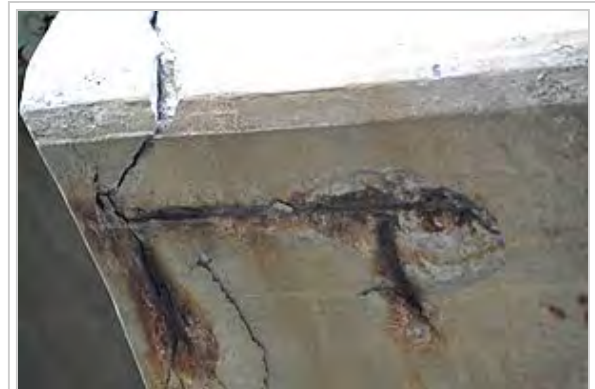
Degraded concrete and rusted, exposed rebar on Welland River bridge of the Queen Elizabeth Way in Niagara Falls, Ontario.

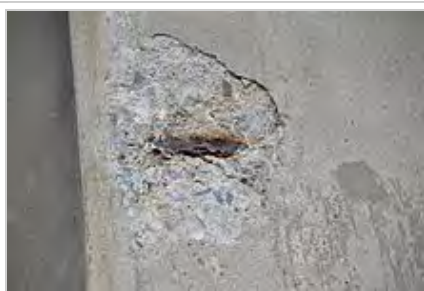
Example of flat piece of concrete having dislodged with corroded rebar underneath, Welland River bridge across Queen Elizabeth Way in Niagara Falls, Ontario.

The expansion of the corrosion products (iron oxides) of carbon steel reinforcement

structures may induce mechanical stress that can cause the formation of cracks and disrupt the concrete structure. If the rebars have been poorly installed and are located too close to the concrete surface in contact with the air, spalling can easily occur: flat fragments of concrete are detached from the concrete mass by the rebars corrosion and may fall down.

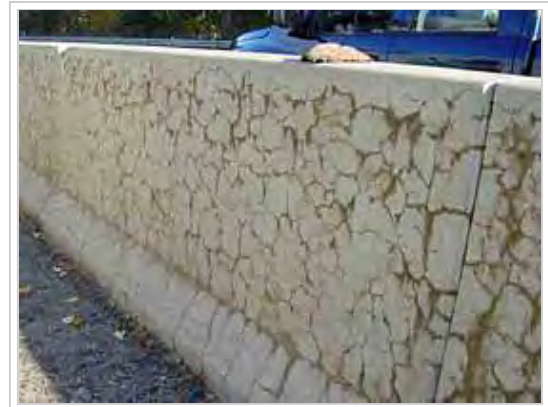
Typical crack pattern associated to the alkali-silica reaction affecting a concrete step barrier on a US motorway (photograph, courtesy of the Federal Highway Administration (US Department of Transportation).

Various types of aggregate undergo chemical reactions in concrete, leading to damaging expansive phenomena. The most common are those containing reactive silica, that can react (in the presence of water) with the alkalis in concrete ( $K_2O$  and  $Na_2O$ , coming principally from cement). Among the more reactive mineral components of some aggregates are opal, chalcedony, flint and strained quartz. Following the alkali-silica reaction (ASR), an expansive gel forms, that creates extensive cracks and damage on structural members. On the surface of concrete pavements the ASR can cause pop-outs, i.e. the expulsion of small cones (up to 3 cm (1 in) about in diameter) in correspondence of aggregate particles.

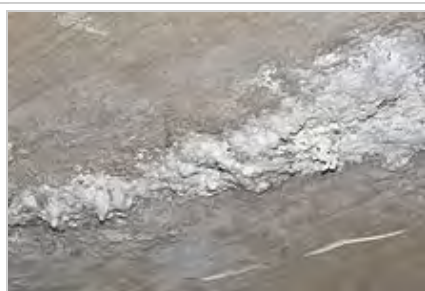
Example of secondary efflorescence in parking garage exposed to diluted road salt from vehicles entering the garage during winter.

When water flows through cracks present in concrete, water may dissolve various minerals present in the hardened cement paste or in the aggregates, if the solution is unsaturated with respect to them.

Dissolved ions, such as calcium ( $\text{Ca}^{2+}$ ), are leached out and transported in solution some distance. If the physico-chemical conditions prevailing in the seeping water evolve with distance along the water path and water becomes supersaturated with respect to certain minerals, they can further precipitate, making deposits or efflorescences inside the cracks, or at the concrete outer surface. This process can cause the self-healing of fractures in particular conditions.

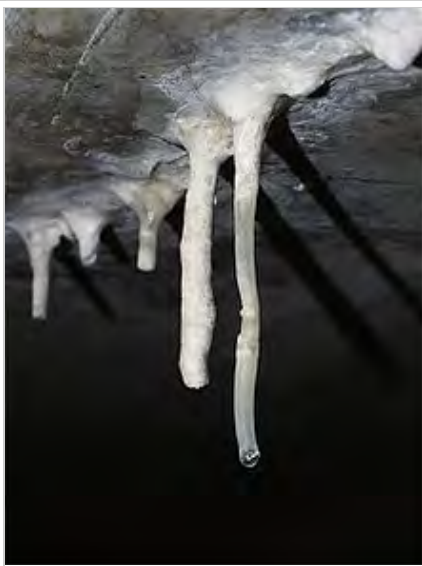
Stalactites growing beneath a concrete structure as a result of calcium hydroxide being leached from concrete and deposited as calcium carbonate to create calthemite forms beneath structure

Within set concrete there remains some free "calcium hydroxide" ( $\text{Ca}(\text{OH})_2$ ),<sup>[8]</sup> which can further dissociate to form  $\text{Ca}^{2+}$  and hydroxide ( $\text{OH}^-$ ) ions".<sup>[9]</sup> Any water which finds a seepage path through micro cracks and air voids present in concrete, will readily carry the ( $\text{Ca}(\text{OH})_2$ ) and  $\text{Ca}^{2+}$  (depending on solution pH and chemical reaction at the time) to the underside of the structure where leachate solution contacts the atmosphere.<sup>[10]</sup> Carbon dioxide ( $\text{CO}_2$ ) from the atmosphere readily diffuses into the

leachate and causes a chemical reaction, which precipitates (deposits) calcium carbonate ( $\text{CaCO}_3$ ) on the outside of the concrete structure. Consisting primarily of  $\text{CaCO}_3$  this secondary deposit derived from concrete is known as "calthemite"<sup>[10]</sup> and can mimic the shapes and forms of cave "speleothems", such as stalactites, stalagmites, flowstone etc.<sup>[11]</sup> Other trace elements such as iron from rusting reinforcing may be transported and deposited by the leachate at the same time as the  $\text{CaCO}_3$ . This may colour the calthemites orange or red.

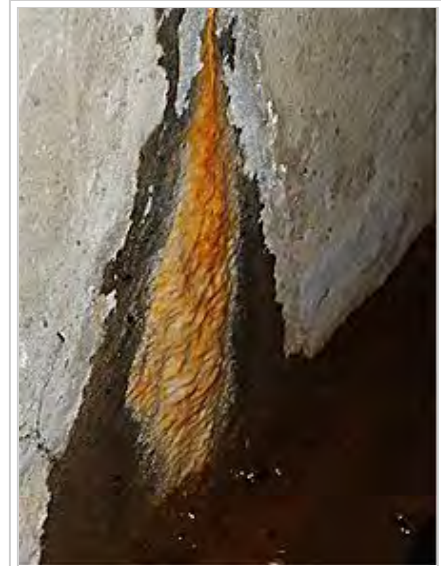
Calthemite flowstone stained orange from rusting reinforcing (iron oxide) being deposited along with calcium carbonate

The chemistry involving leaching of calcium hydroxide from concrete can facilitate the growth of calthemites up to  $\approx 200$  times faster than cave speleothems due to the different chemical reactions involved.<sup>[13]</sup> The sight of calthemite is a visual sign that calcium is being leached from the concrete structure and the concrete is gradually degrading.<sup>[10][14]</sup>
