Small village systems - Villa Las Araucarias

E. Ian Baring-Gould
National Renewable Energy Laboratory
Golden, CO. USA

• Villa Las Araucarias

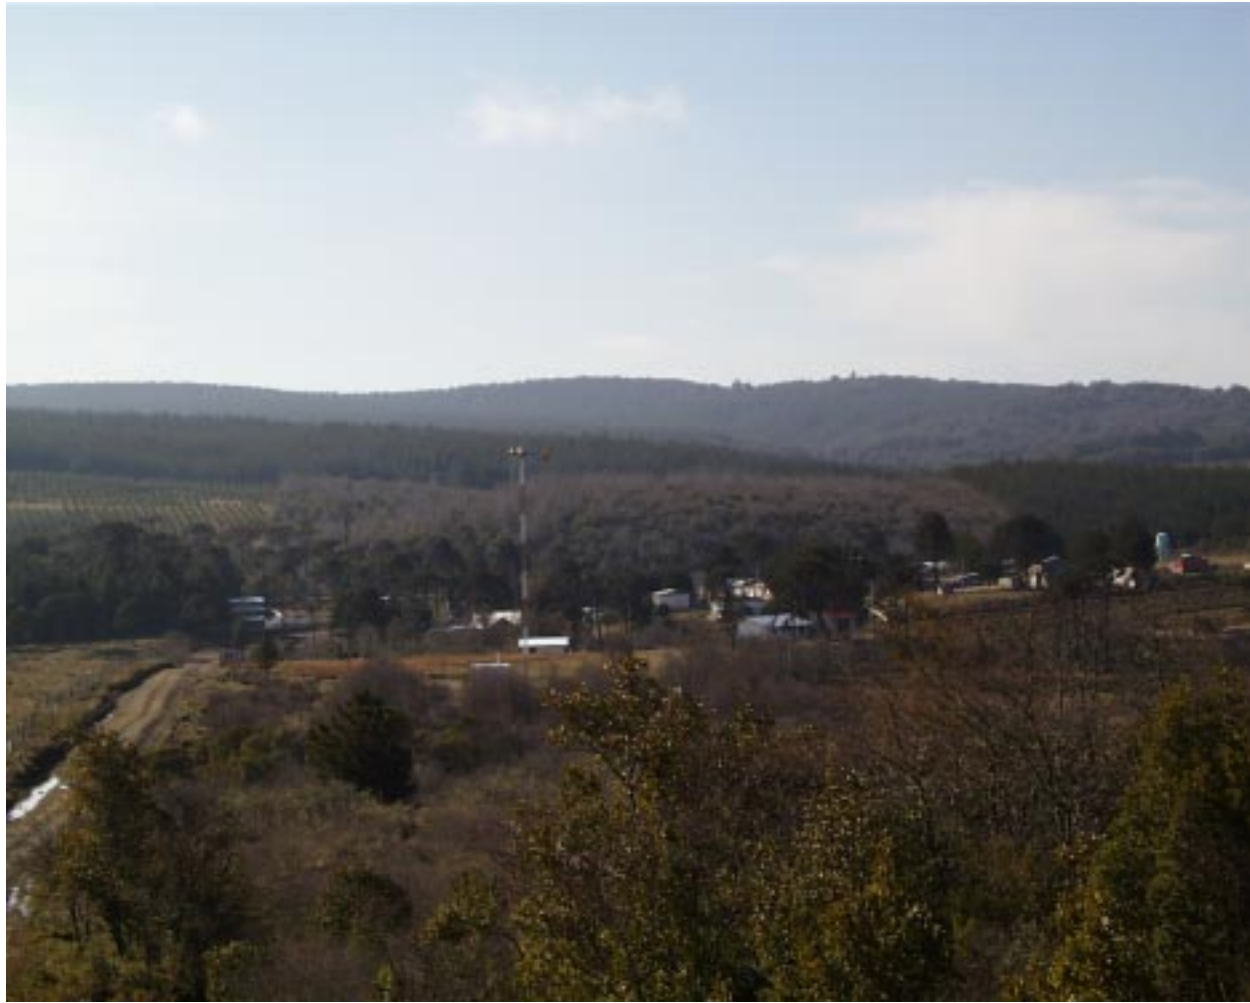
Villa Las Araucarias

- **Inland community on the coastal range**
- **Mainly supported by forest industry**
- **Health post, school and 17 homes**
- **Community very prosperous and growing**
- **9.8 kWh daily load with a 1.2 kW peak estimated.**
- **Average wind speed of 4.8 m/s**

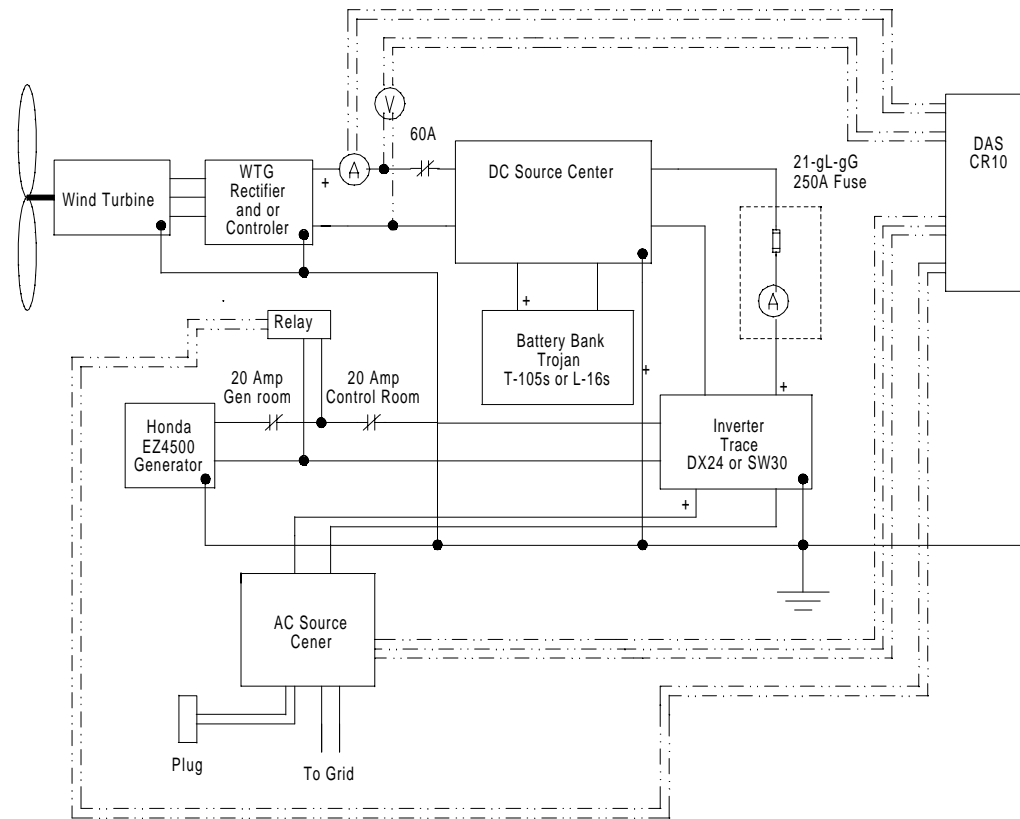
Basic System Design

Power System Components

- **Bergey Windpower Excel 10kW wind turbine**
 - **33.6 kWh battery bank of Trojan L-16's**
 - **Trace Engineering SE3024E inverter**
 - **Honda EM4500S 5.4 kW auto-start gasoline generator**
 - **48 Volt DC bus with no DC loads**
 - **220 V, 50 Hz AC distribution on a 0.91 km grid**
-
